NRL/MR/6136--00-8491

# USS Virginia Ballast Tank Connector Qualification Study

September 29, 2000

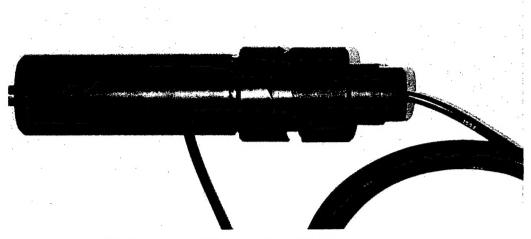
Concept C consisted of a solid PVC housing, as seen in Figure 1, while Concept D used a polyurethane mold at the cable connection, as shown in Figure 2. During unpacking of the connector assemblies, it was discovered that one of the Concept C assemblies was damaged in shipment. The threaded outer housing was cracked and indicated that the cap was probably over tightened during the assembly processes. Evidently a stress riser was created at a weak area of the cap, noted at the point in (Figure 3). The broken connector was returned to the manufacturer and a replacement assembly was received on May 16, 1999.

Figure 3. Photograph of Connector Failure during shipping

- Because of the mechanical failure, which occurred during shipping, it is
  recommended that the machine specification for the "Concept C" connector be
  reviewed to insure that the connector cap cannot be over-tightened and that
  sufficient thread length is available to insure correct tightening and sealing without
  stressing the PVC cap during assembly.

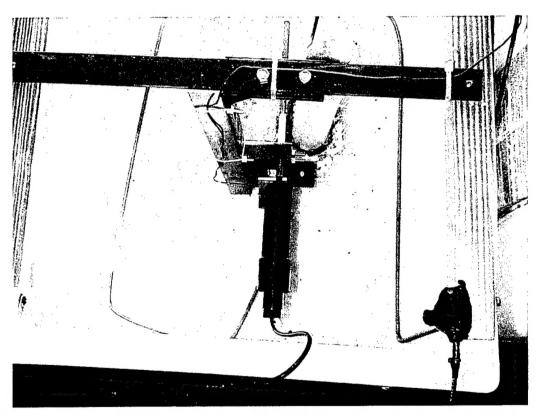
**Figure 4.** Photograph of Connector Concept C with entire test assembly, including reference electrode, PVC (Type 2) standoff with 304 stainless steel bolts, and Pt/Nb cathode.

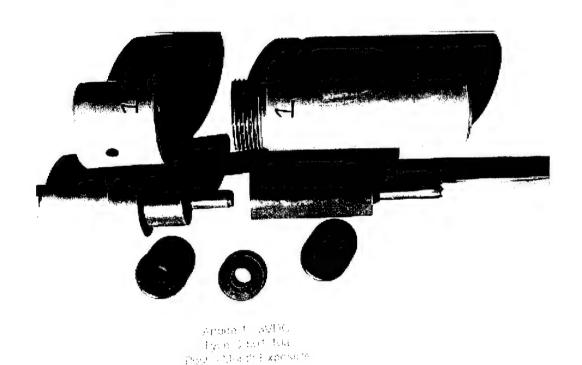
The average driving voltages, anode potentials and current outputs measured during the test duration are given in Table 4. Anodes #1-4 were controlled to 3V output, using a silver/silver chloride (Ag/AgCl) reference electrode, located directly below the anode surface. As a consequence, the anode current floated and changed to maintain the constant voltage. Figure 6 and Figure 7 show disassembled, 3V condition, anode connectors examined immediately after removal from test. Figure 6 shows the "Concept C" and Figure 7 shows the "Concept D" designs. Neither connector showed any sign of leakage during the test and structurally had no degradation of the PVC body, washer or anode rod. The molded polymer boots showed minor discoloration and surface texturing, but no penetration or cracking.

**Figure 6.** Post-exposure photo of Anode 1 connector assembly (Concept C), which was, tested potentiostatically at 3 VDC vs. Ag/AgCl for 6 months

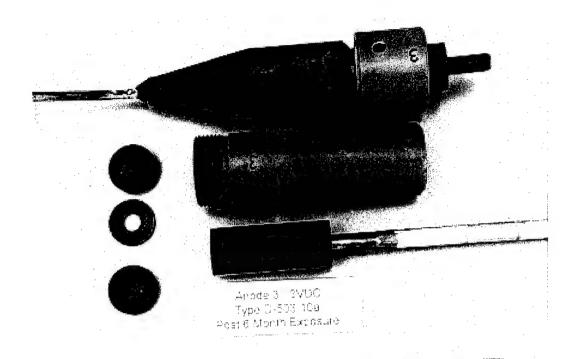
**Figure 7.** Post-exposure photo of Anode 3 connector assembly (Concept D), which was, tested potentiostatically at 3 VDC vs. Ag/AgCl for period of 6 months.

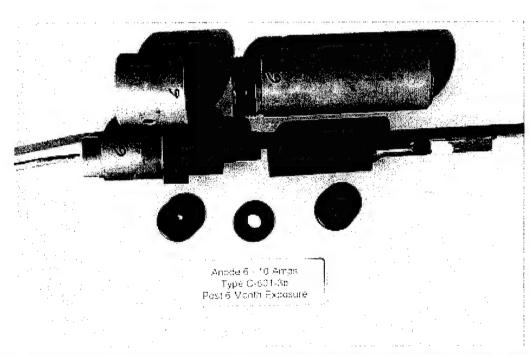
Anodes #5-8 were current controlled to 10 A, thus the driving voltage floated and adjusted to maintain the constant current output. Voltages as high as 11 volts were observed and were within the design parameters of the USS Virginia equipment output specification (EB #4103, Sec 3.5.3.1). Figure 8 and Figure 9 show disassembled anode connectors examined immediately after removal from test. Figure 8 shows the "Concept C" and Figure 9 shows the "Concept D" designs. Again, neither connector showed any sign of leakage during the test and structurally had no degradation of the PVC body, washer or anode rod. The molded polymer boots were not degraded over that observed in the lower voltage connectors and again had minor discoloration and surface texturing, but no significant deterioration or cracking.

**Figure 8.** Post-exposure photo of Anode 6 connector (Concept C) assembly which was tested galvanostatically at 10 A for a period of 6 months.

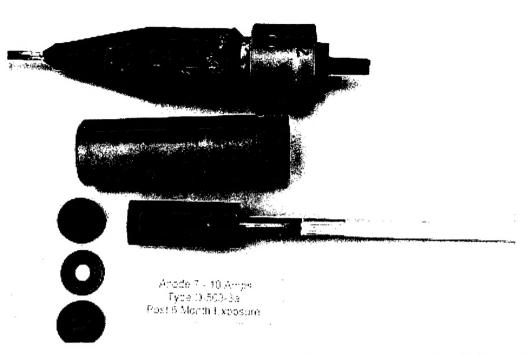
Figure 9. Post-exposure photo of Anode 7 (Concept D) connector assembly which was tested galvanostatically at 10 A for period of 6 months.

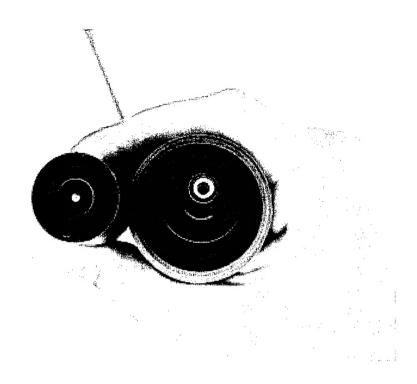
No deterioration of the Cu conductor in any of the connectors was noted, as seen on the Cu contacts, shown in Figure 10. The PVC stand-off material and 304 stainless steel bolts, shown in Figure 11, were exposed to a severe environment at the anode surface. No deterioration of the PVC was noted other than discoloration, however, the 304 stainless steel bolts were severely affected by the localized corrosion attack, possibly accelerated by the high chlorine concentration. In general, the bolts showed evidence of severe crevice attack at the most concealed surfaces and were additionally pitted at various locations. In practical application, the chlorine level would not be high, however, the environment at the anode surface could possibly generate some chlorine or create conditions favorable for crevice attack regardless of the presence of chlorine. The normal operation of the ICCP in the ballast tank has been designed to maintain voltages below the level for chlorine generation, but the possibility for crevice attack remains a corrosion issue. While not directly part of this study, use of less crevice corrosion susceptible bolts/material would be advantageous in this application.

Figure 10. Photograph of interior Cu electrical connection post 6 month study.

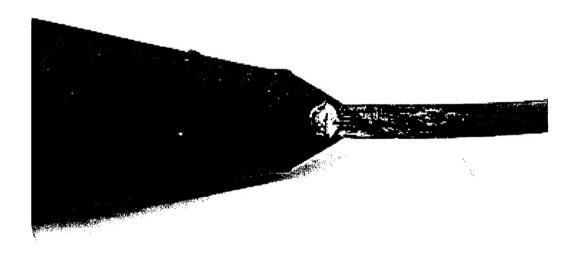
Figure 13. Photograph of poor polyethylene mold at the cable entry after immersion testing

- 3. It is recommended that the molding quality assurance be carefully monitored to eliminate the presence of bubbles and voids within the stress relief boot of the "Concept D". Anode connectors should not be accepted with this type of defect.
